VX750S

EXHAUST PIPE BREAKAGE

CLUTCH UPDATE

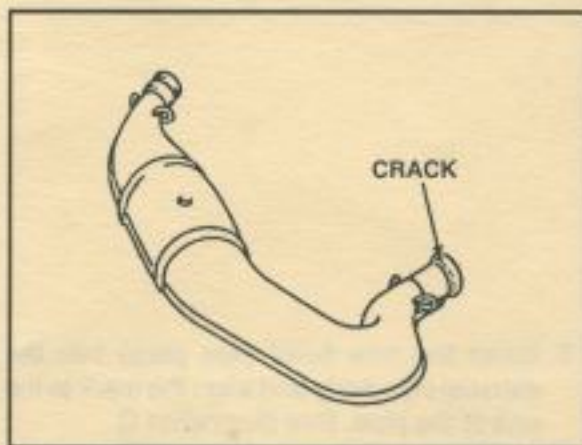
When used extensively on rough trails, the exhaust pipe may crack at the header pipe joint area. Refer to the illustration.

PROBLEM: Excessive wear and subsequent cracking in the header pipe to "Y"-pipe joint area.

CAUSE: Insufficient material thickness.

REMEDY: Repair the exhaust pipe by cutting off the cracked head pipe and welding a new head pipe piece in its place. Replace the pipe #2 (LH) securing spring with a new shorter spring.
